Mobile Intel[®] Pentium[®] II Processor Specification Update

Release Date: August 2001

Order Number: 243887-033

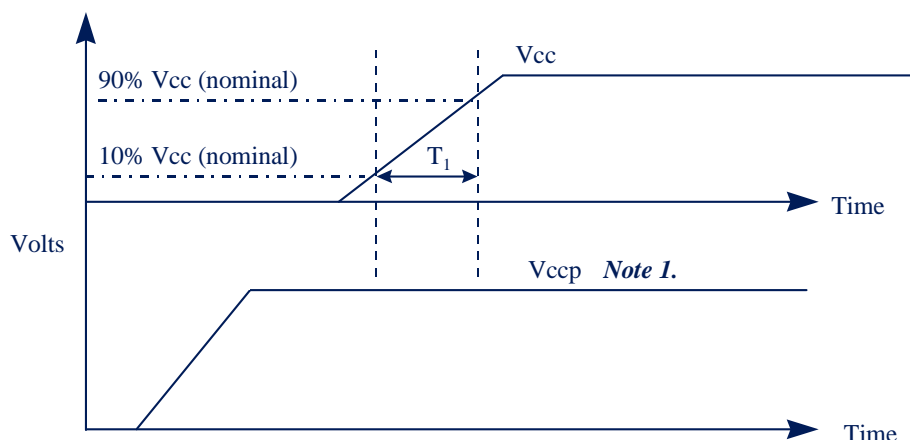
Figure 1. VCC/VCCP Timing Requirements (Mobile)

Problem: The processor uses the PWRGOOD signal to ensure that no voltage sequencing issues arise; no pin assertions should cause the processor to change its behavior until this signal is asserted, when all power supplies and clocks to the processor are valid and stable. However, if V_{CC} ramps up before V_{CCP} , it will cause the processor to enter an invalid state.

Implication: If this erratum occurs, the system may boot normally however, the L2 cache may not be initialized.

Workaround: For Mobile Pentium II processors, ensure that V_{CC} ramps after or with the L2 cache IO voltage (V_{CCP}). If V_{CCP} ramps after the V_{CC} , a delay circuit can be placed on the core V_{CC} to ensure that V_{CC} ramps at the same time or after V_{CCP} as shown below in Figure 1.

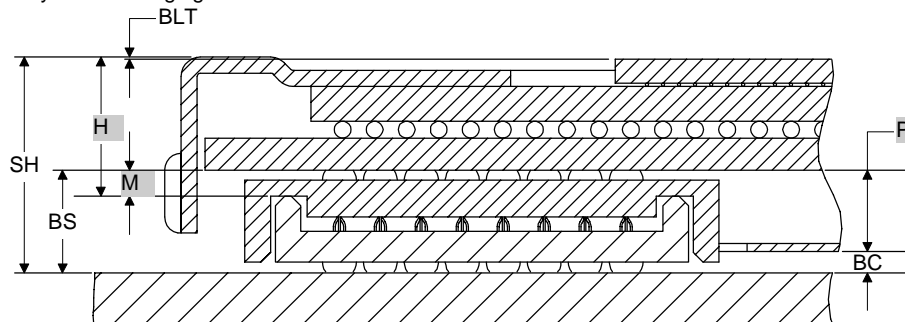
Figure 5.6. Cross Sectional View with Vertical Dimensions

B1. Misabeled Vertical Dimension Parameters

Figure 5.6 in the *Mobile Pentium® II Processor at 233 MHz, 266 MHz, and 300 MHz* datasheet should be replaced by the following figure:
